**Technical Service  
BULLETIN**

**BLOWER MOTOR  
ABNORMAL OPERATION**

'03 – '05 4Runner

HEATING & AIR CONDITIONING  
AC004-05  
REVISED

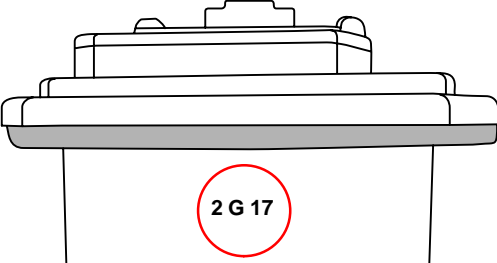
Countermeasure service parts are identified by the 4–digit date code printed on the side of the blower motor controller cooling fins. Date code is 2 G 17 or later.
