4th Gen, 2005, V6, SR5 4Runner was making a terrible clunk noise as the driver's side window was lowered past about half way. I opened up the door panel, inspected everything inside, found no problem, and the window worked great. Put the door back together and the window worked great. Got in, went for a drive, and the window clunked again.

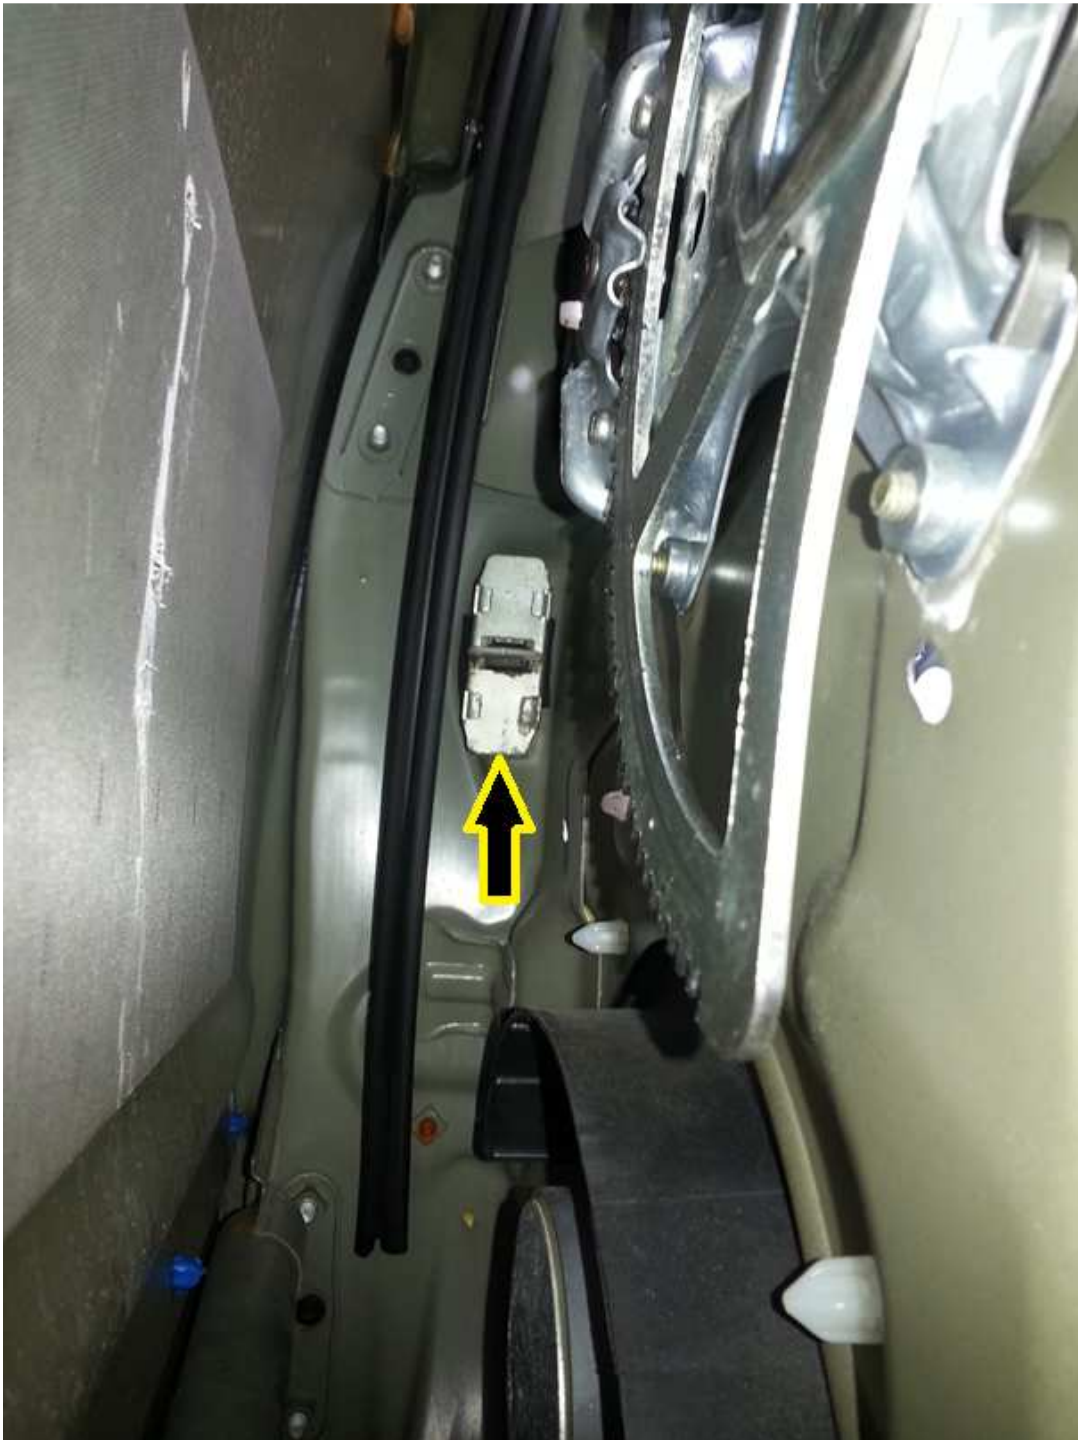
Arrow below shows the door stay from inside the door when the door is completely open.

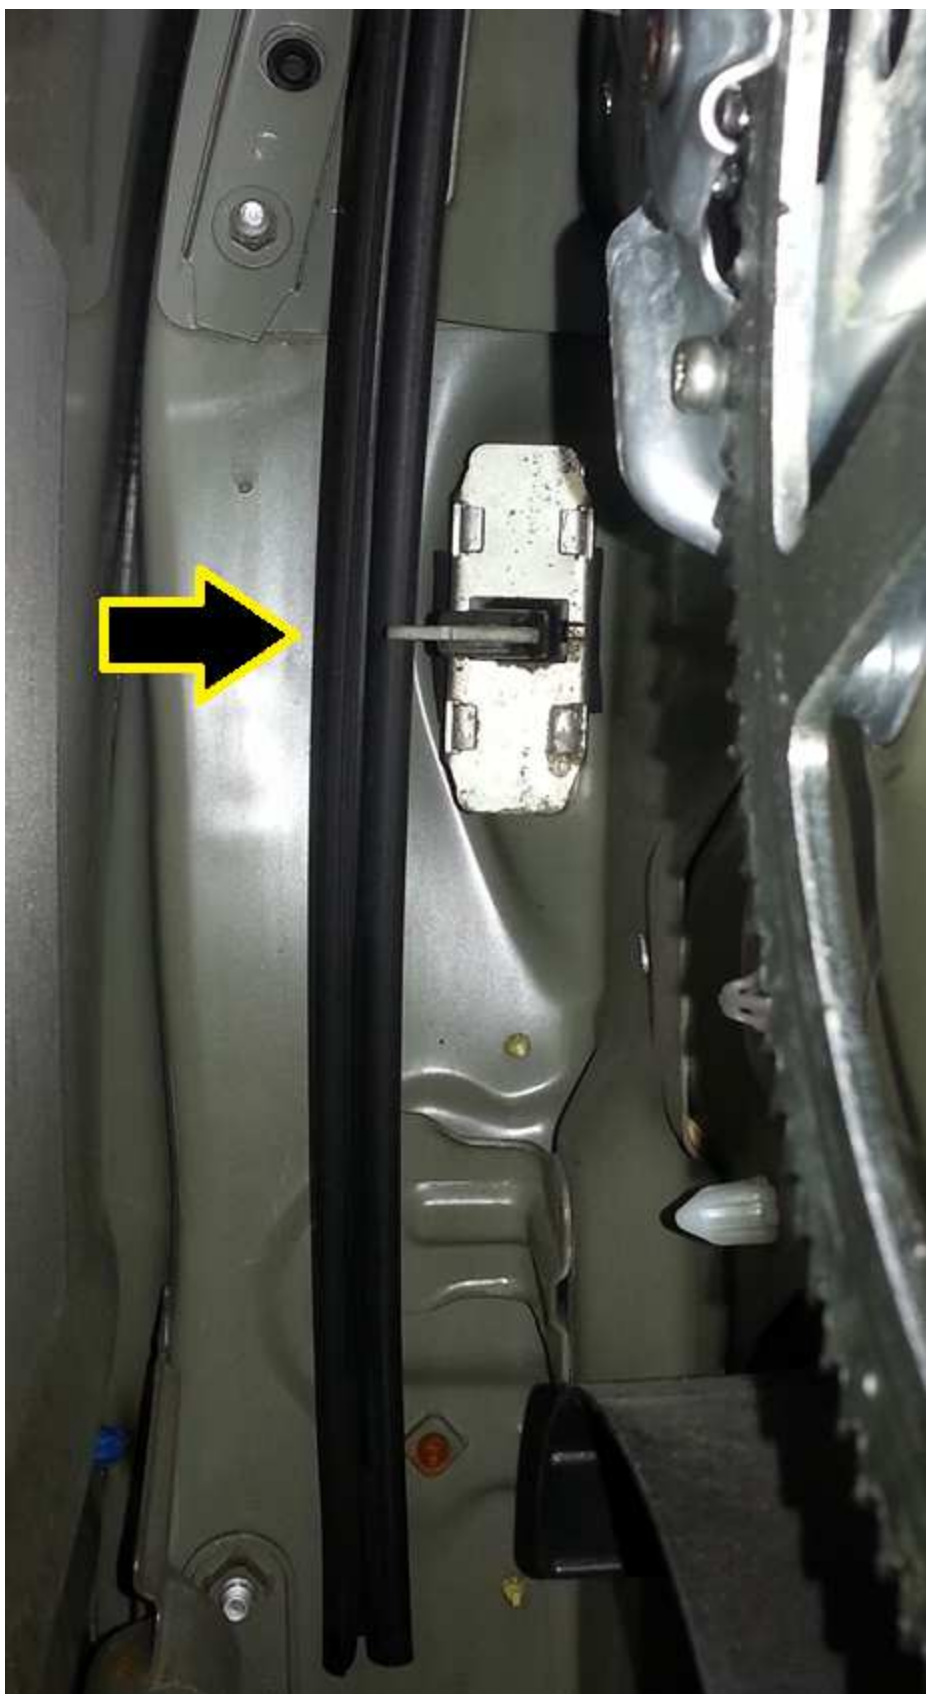
Arrow below shows the door mostly closed. The end of the door stay is advancing towards the window channel.

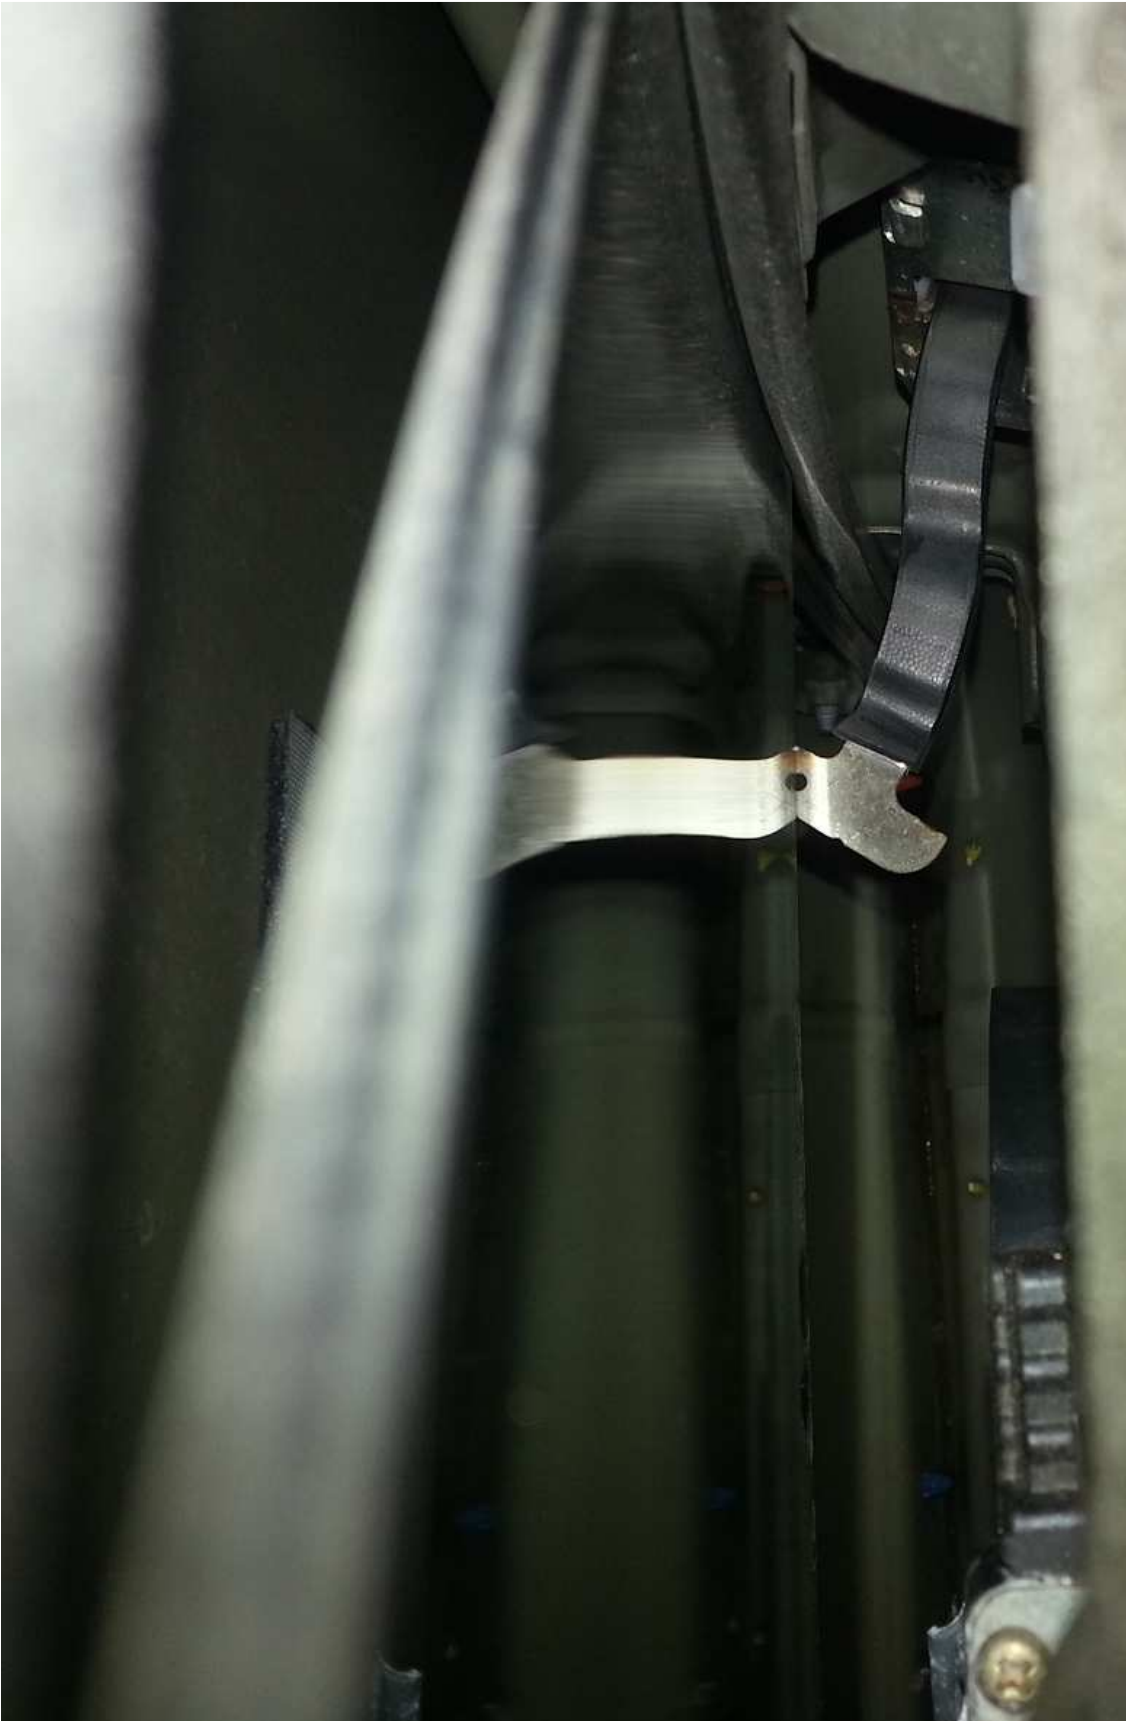
The problem ended up being that the end of the door stay was in the window's path when the door was closed. It is clear that my door had been previously disassembled. I don't know the history. Probably had the window regulator or motor replaced.

Pic below was taken with the door completely closed and the window rolled down until it was about to hit the door stay. It hits directly on the glass.

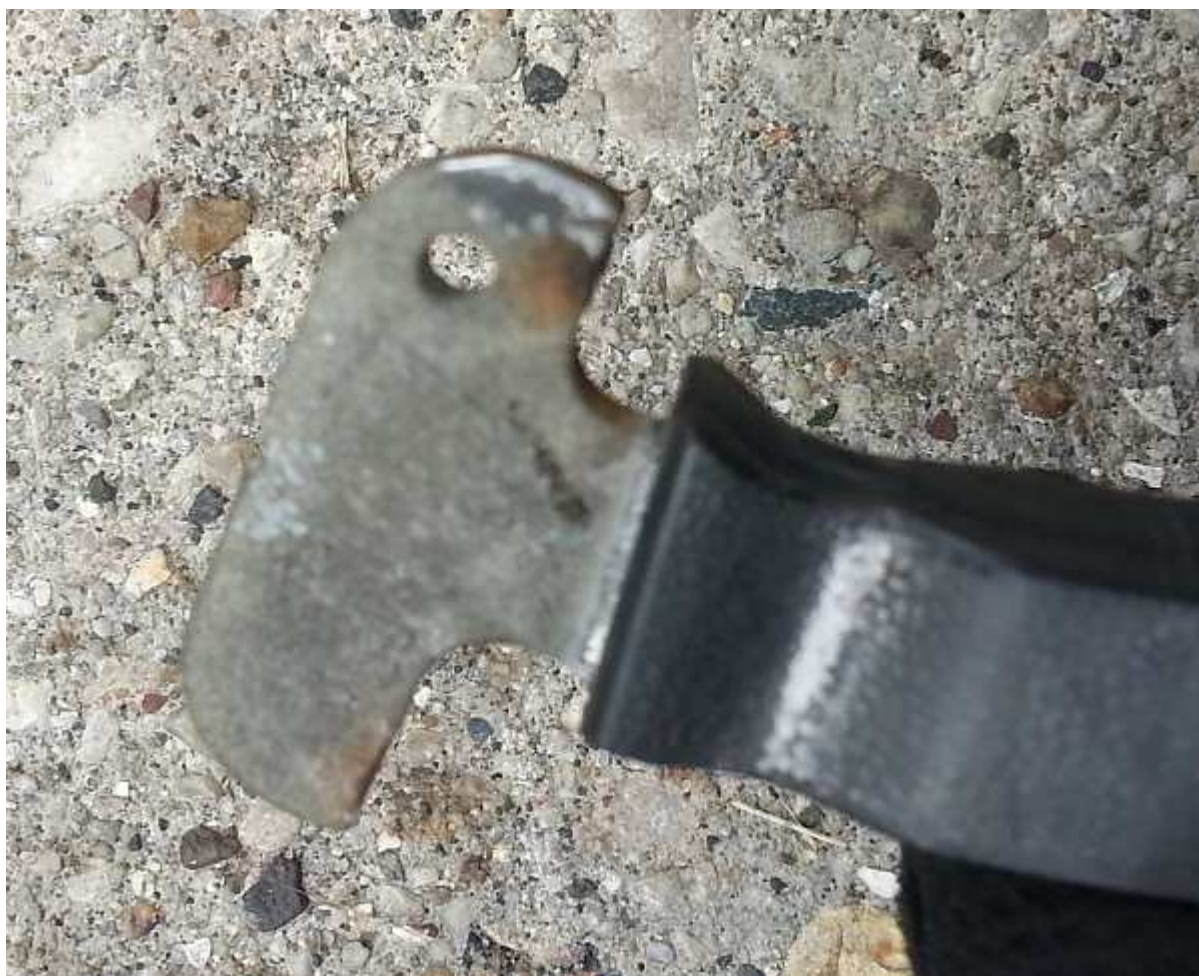
Close up showing where the glass had been hitting it. I'm really lucky that my window didn't shatter .
