**Technical Service  
BULLETIN**

**BLOWER MOTOR  
ABNORMAL OPERATION**

'03 – '05 4Runner

HEATING & AIR CONDITIONING  
AC004-05  
REVISED

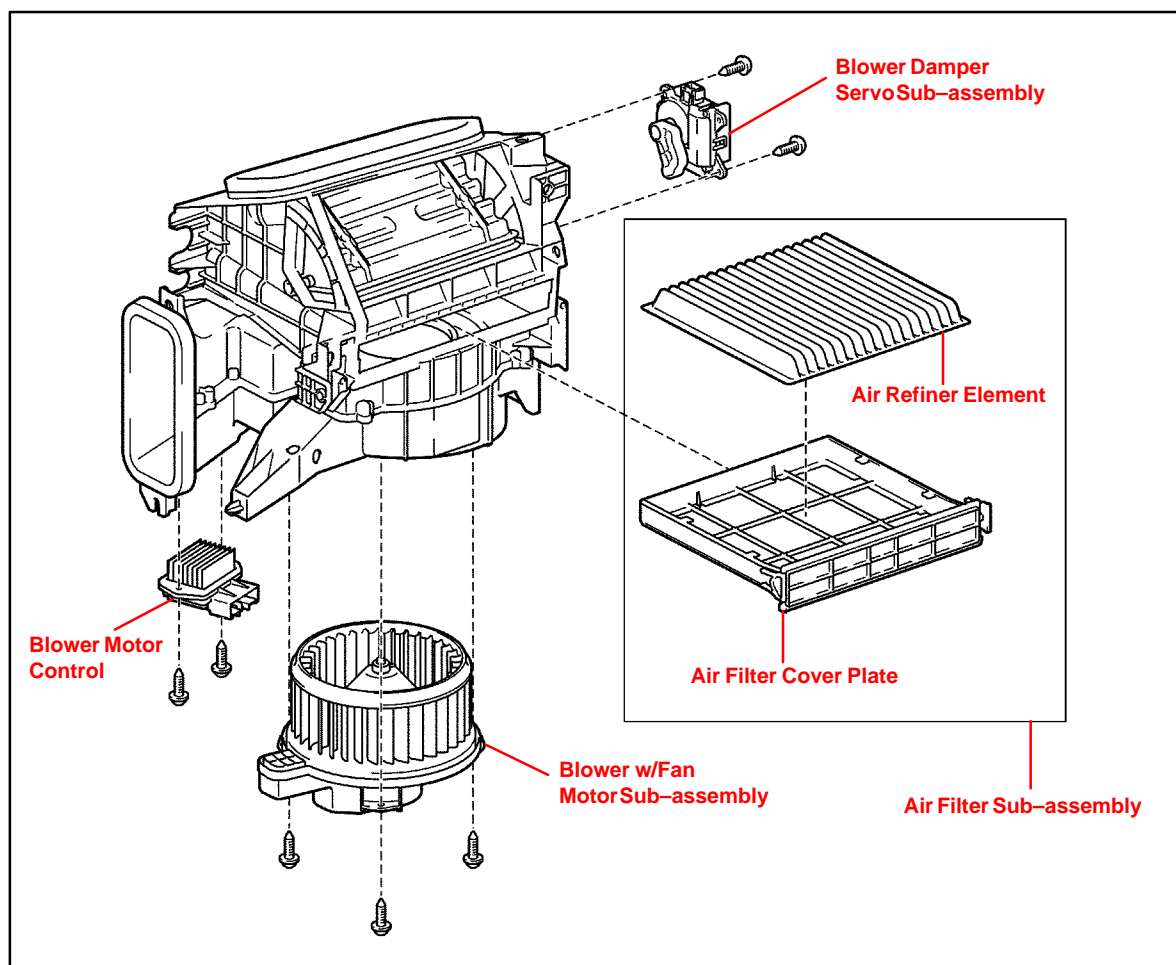
## Components

**Introduction** Some 2003 – 2005 model year 4Runner vehicles may experience a condition where the blower motor speed does not match the HVAC display indication. The blower motor controller has been modified to resolve this condition. Follow the repair procedure described in this TSB.

1. Remove the negative (–) battery terminal.
